Merrimack River Bathymetry
 1.0 Foot Contour Interval
 Mean Lower Low Water Elevations
 Merrimac to Haverhill, Massachusetts

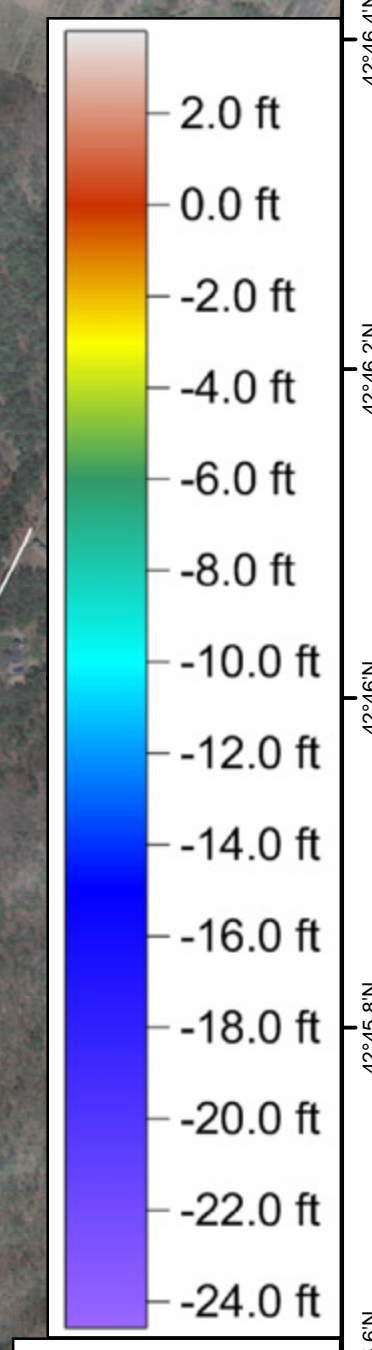
• Potential Hazard

NOTES:
 1. Bathymetry: survey conducted by CR Environmental, Inc. in October 2014.
 2. Base or the photos from MA GIS (2013).
 3. Potential Hazards based on tide gauge water data of features less than 6 feet deep within the navigable channel.
